# National Experiences with Early Warning Systems and Monitoring

U.S. Geological Survey

USEPA Region 10 CyanoHABs Workshop and Tabletop Exercise

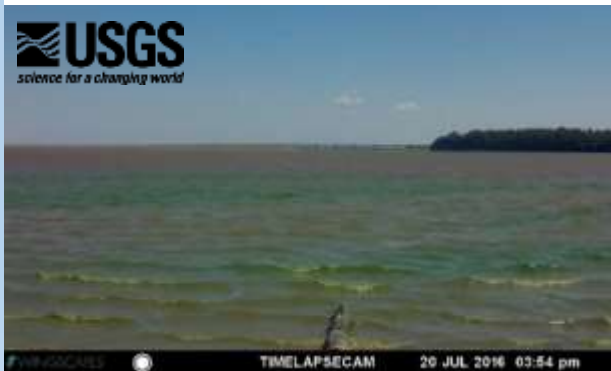
# Aerial- and Ground-Based Cameras Show Potential as Early Indicators

July 20, 2016 at 3:54 pm

Milford Lake, KS

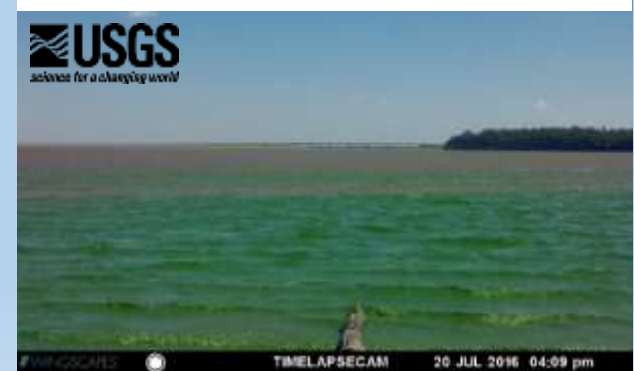
July 20, 2016 4:09 pm

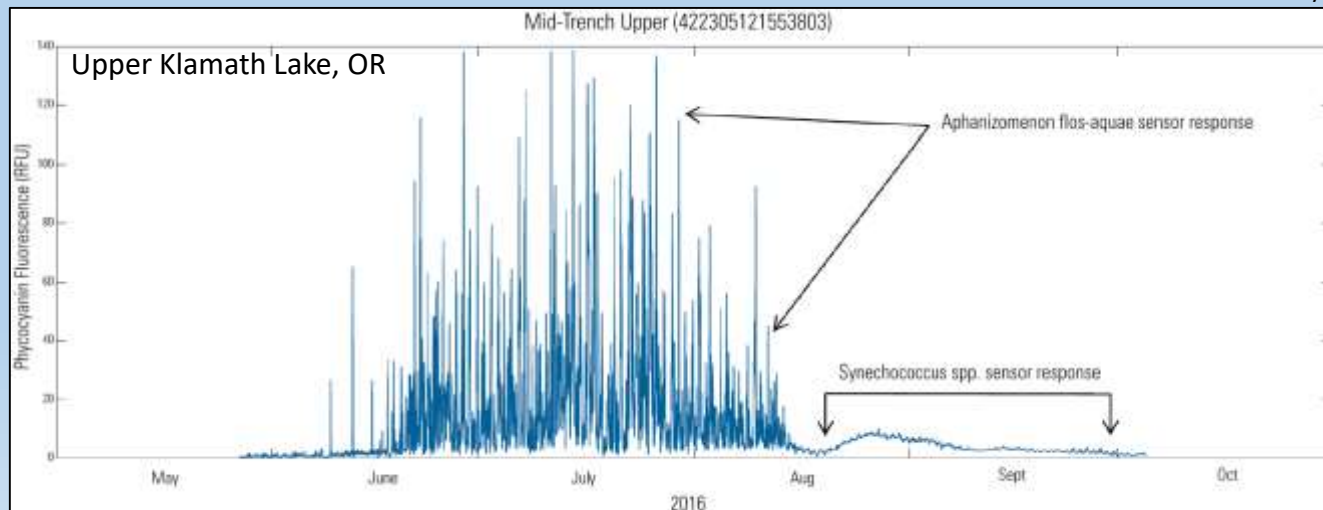
# Diurnal or Noisy Patterns in Algal Fluorescence May Be Indicative of Potentially Harmful Algal Blooms

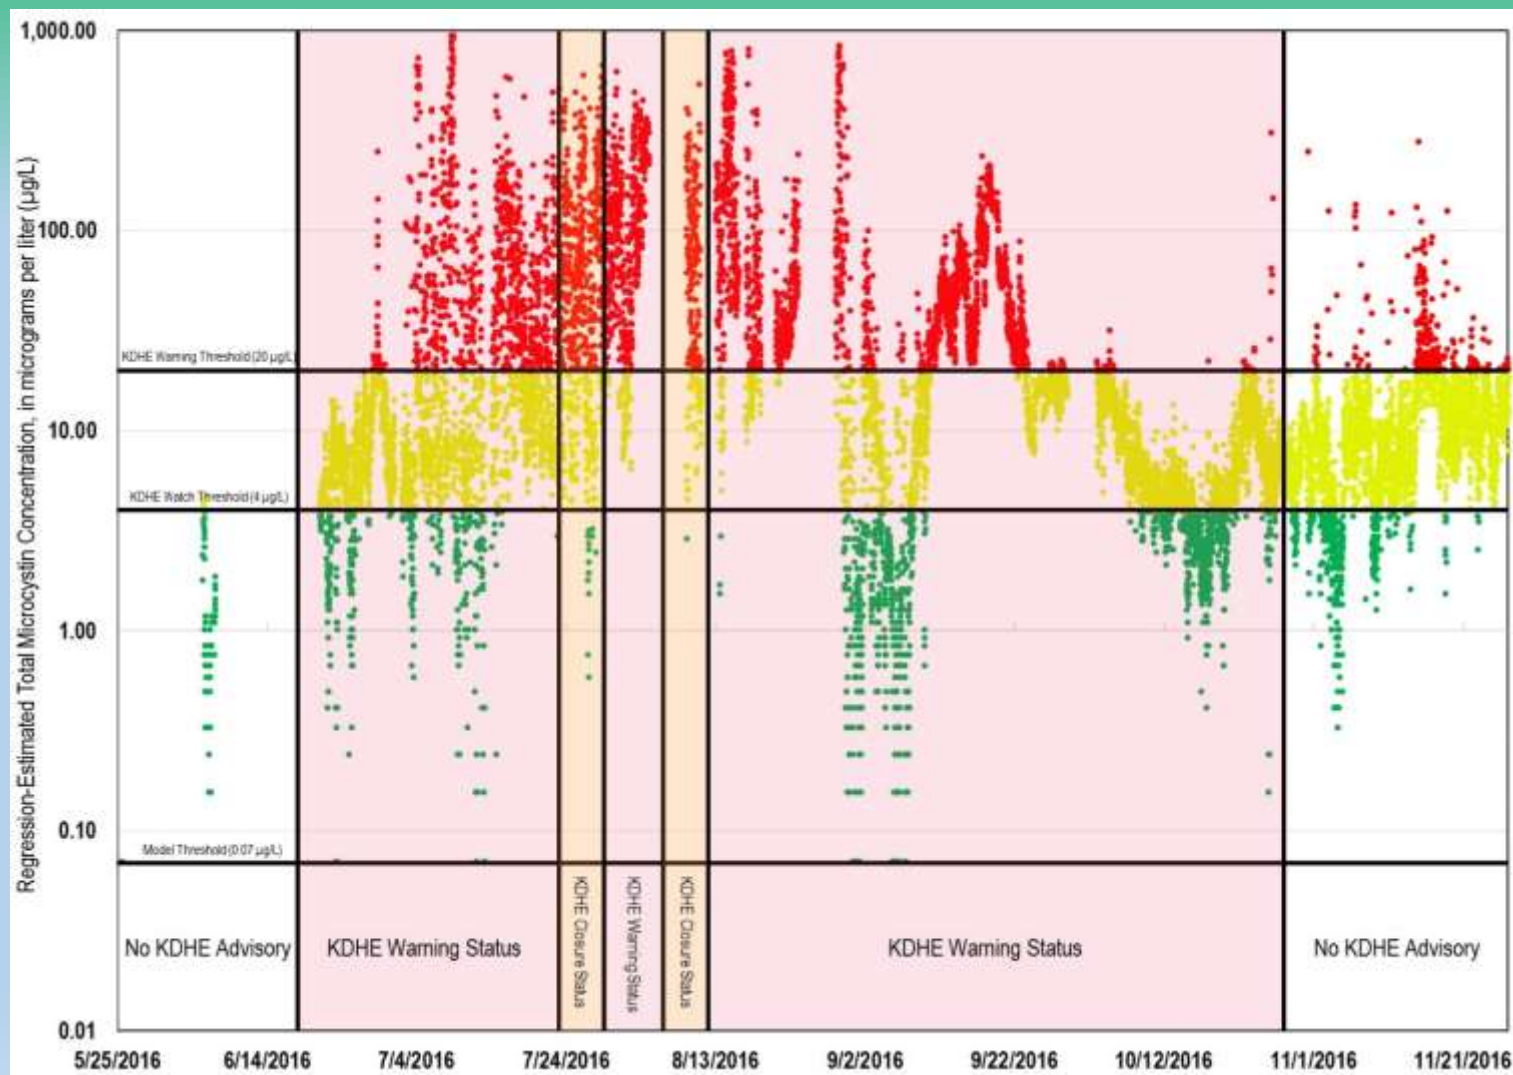
# Sensor Data Can Be Used to Develop Models to Estimate Cyanotoxin Concentrations in Real Time

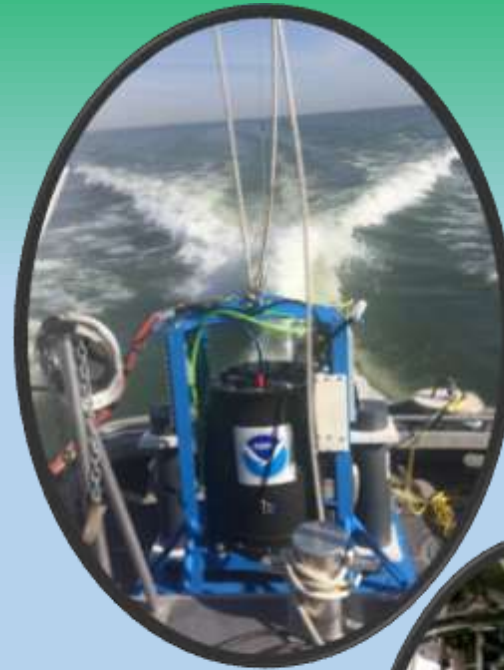
# Environmental Sample Processors

- Cyanotoxins
- Cyanotoxin synthetase genes
- Testing in Lake Erie - Collaboration between NOAA, MBARI, WHOI, OSU
