# Columbia River PCB Cleanup

Alcoa Evergreen Smelter Site  
Vancouver, WA

# **Site Presentation**

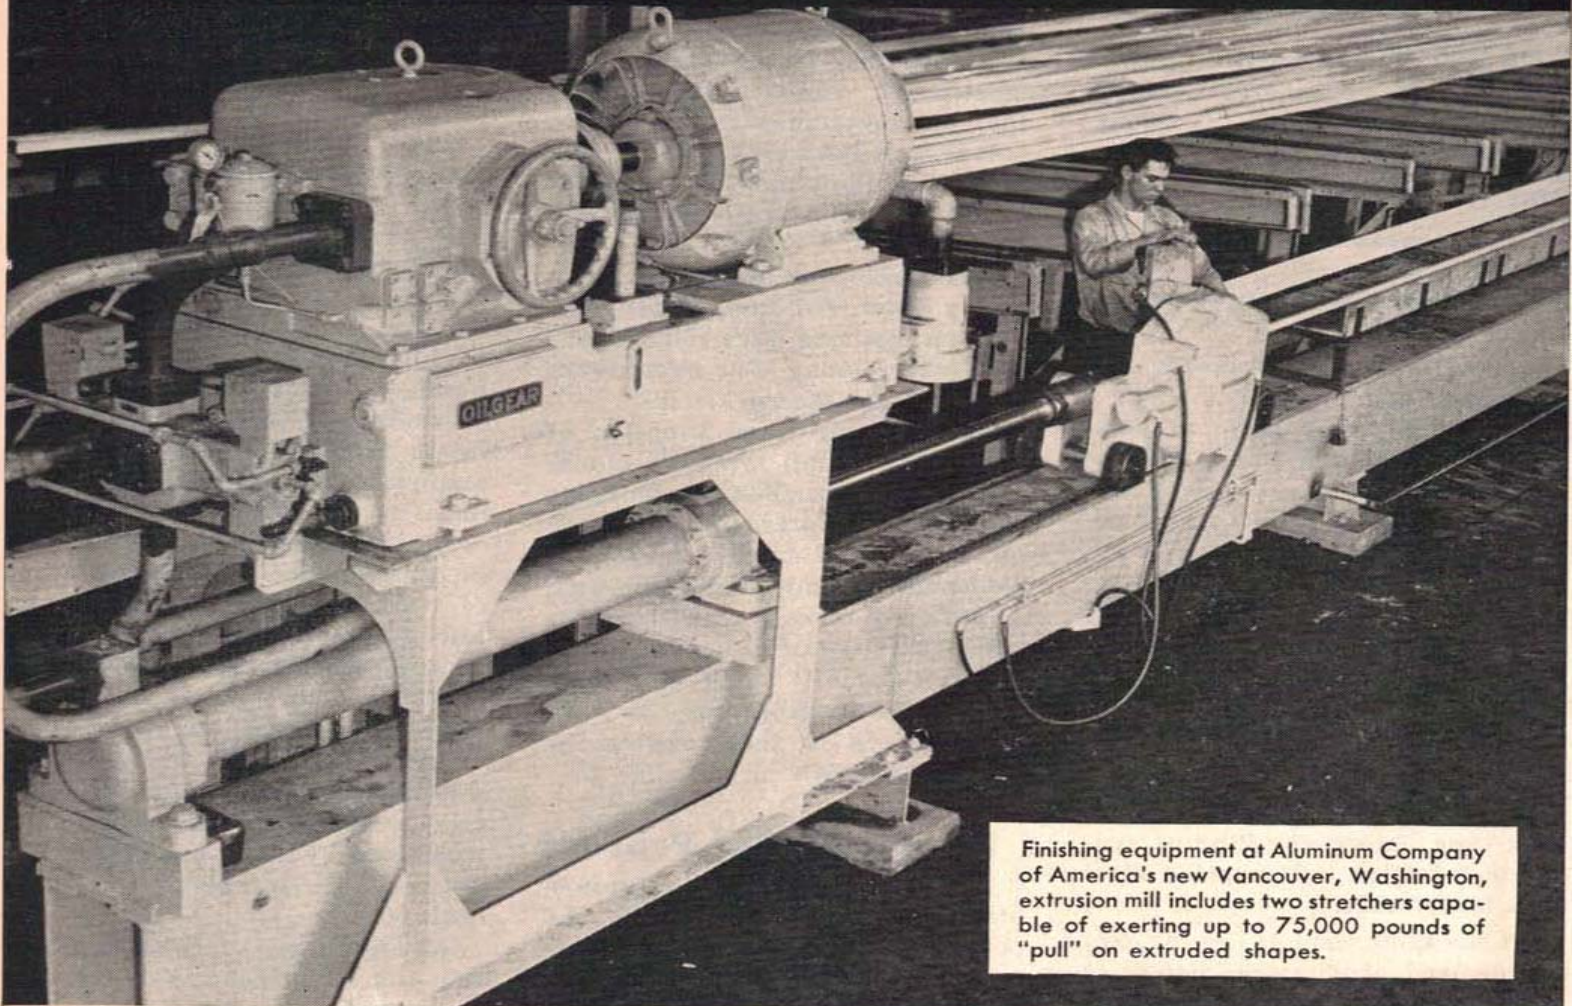
Finishing equipment at Aluminum Company of America's new Vancouver, Washington, extrusion mill includes two stretchers capable of exerting up to 75,000 pounds of "pull" on extruded shapes.

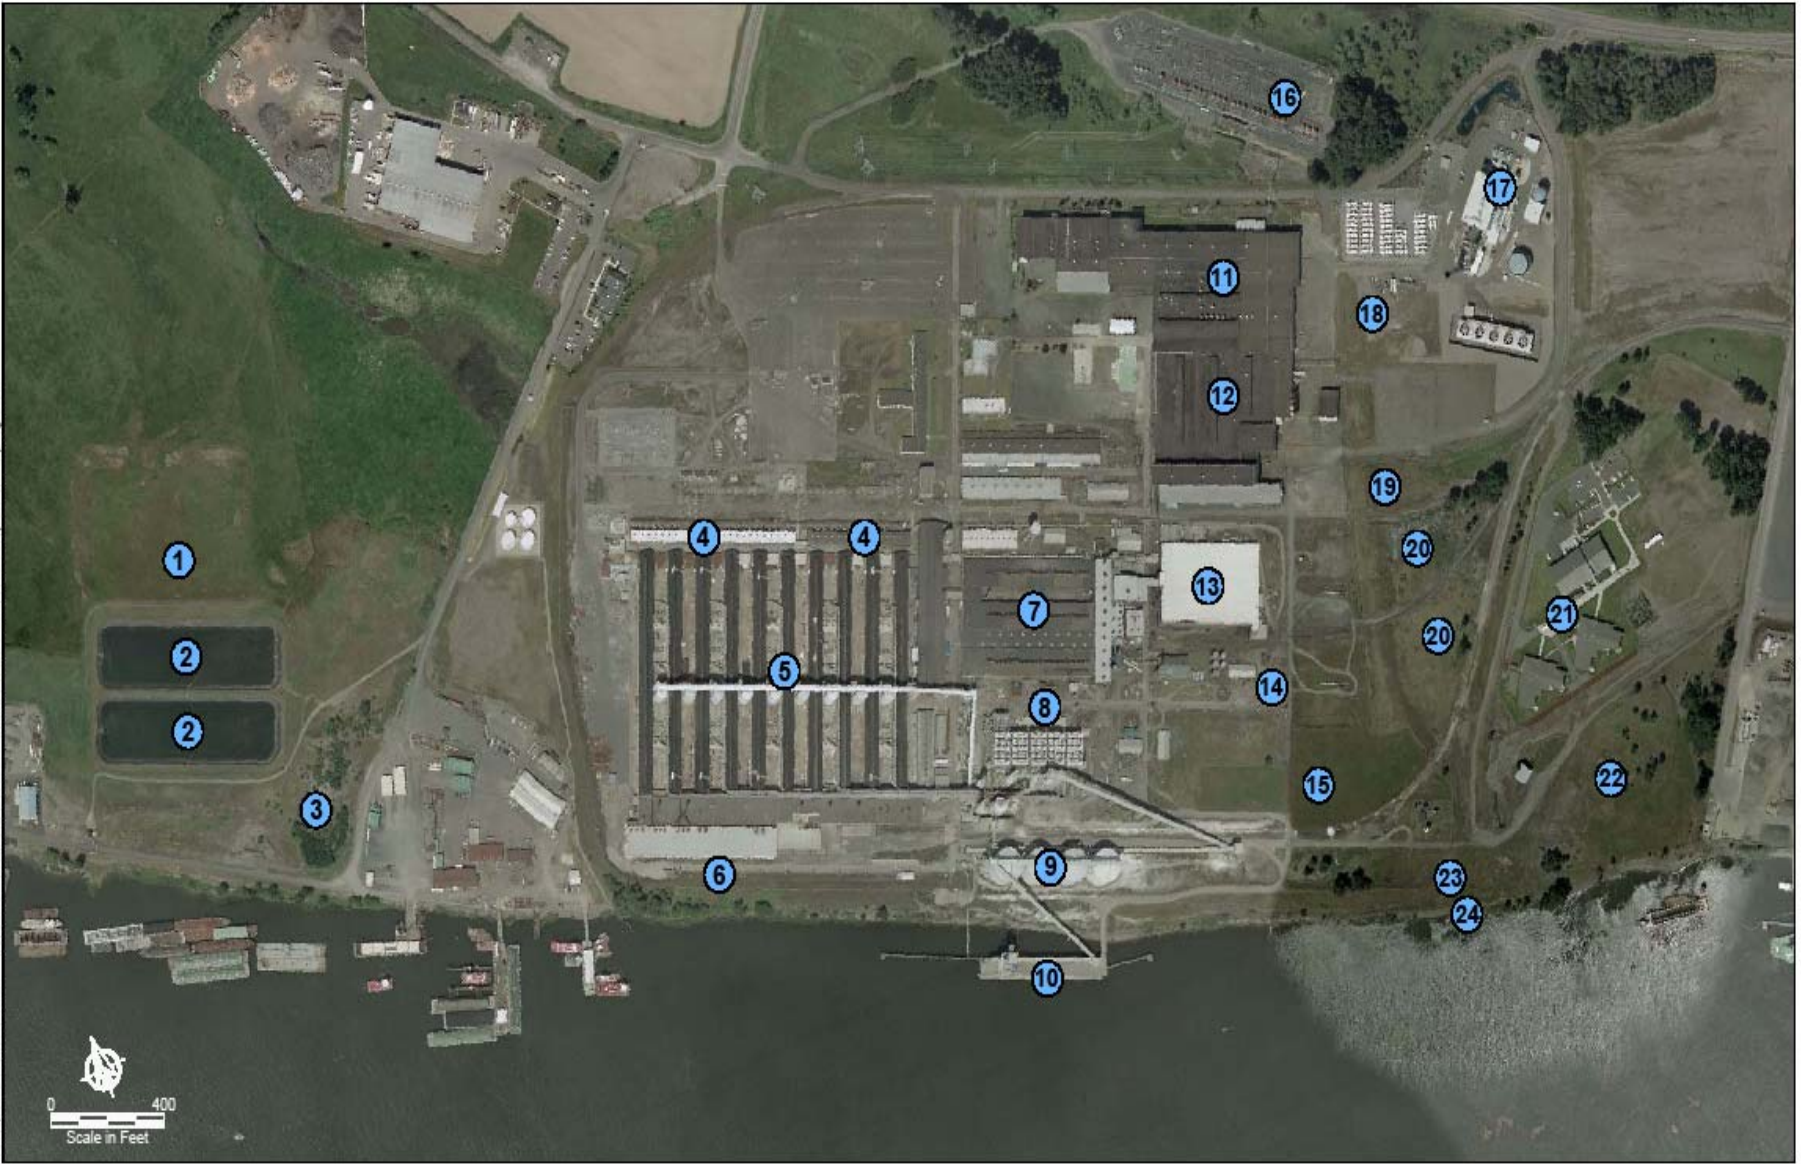
Figure 2-1  
Historical Site Layout  
ALCOA/Evergreen Site  
Vancouver, Washington

| 1 Sludge Pond | 7 Carbon Plant | 13 Carbon Storage | 19 Soluble Oil Area |
| 2 Stormwater Lagoons | 8 Carbon Plant Emission Control System | 14 Scrap Metal Recycling Area | 20 North and North 2 Landfills |
| 3 Crowley Site | 9 Alumina and Raw Material Handling | 15 SPL Storage Area | 21 Northeast Parcel (Clark County Jail) |
| 4 Transformer/Rectifier Yards | 10 Dock | 16 Bonneville Power Station | 22 East Landfill |
| 5 Potlines | 11 Vanexco/Rod Mill Facilities | 17 Clark County Public Utility | 23 South Bank Area |
| 6 Dike UST | 12 ACPC Facilities | 18 Hydraulic Oil Lagoons | 24 CPU Outfall |
